MAGNETIC PERTURBATION INSPECTION OF INNER BEARING RACES

by John R. Barton and James Lankford

SOUTHWEST RESEARCH INSTITUTE

NATIONAL AERONAUTICS AND SPACE ADMINISTRATION • WASHINGTON, D. C. • MAY 1972

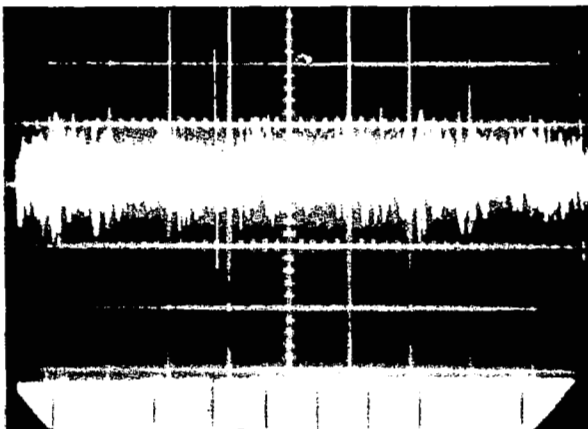
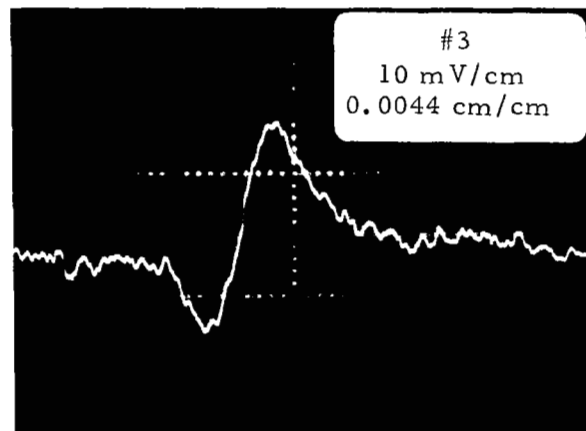
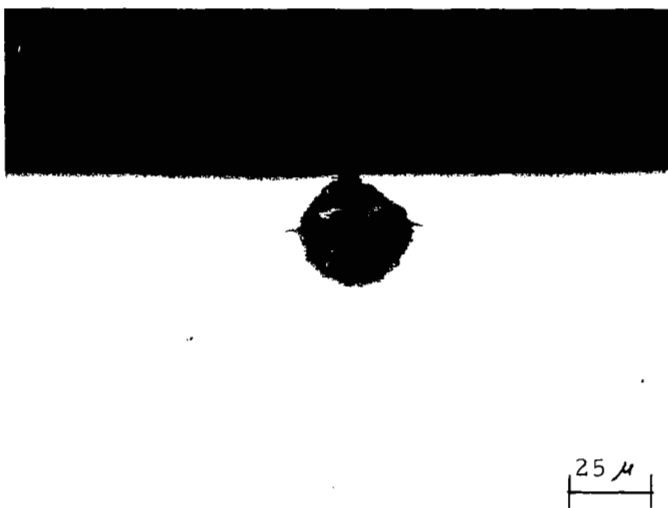
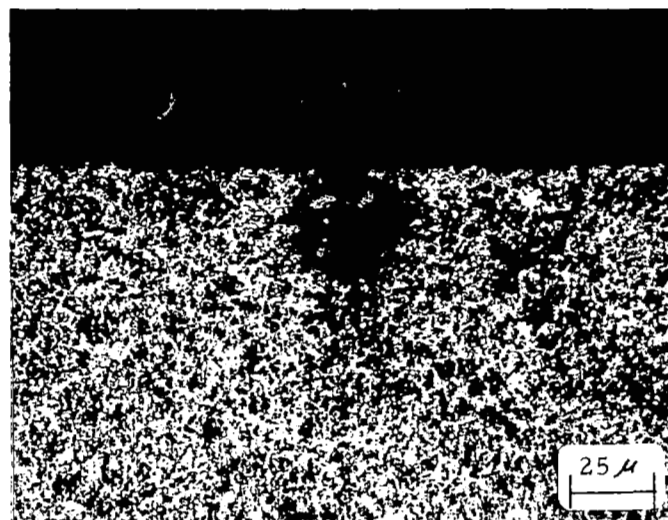
FIGURE 14. SPECIMEN #3 DEFECT SIGNAL AT 5° AND CORRESPONDING DEFECT. (Note cracking evident in Unetched view (c).

The inclusion of specimen No. 3, shown in Figure 14, produced a relatively moderate sized signal of 39 mV. However, no sulfide shell is present, the particle constitutes a good stress raiser, and cracks already have begun to form at 4,000 hours. It is interesting to note that this inclusion is near the center of the ball track, but is considerably smaller than the inclusion in failed specimen No. 24. Despite the presence of microcracks, no deformation-induced etching alteration is evident in Figure 14(d). Note from Table II that specimen Nos. 3 and 6, both quite shallow in depth, generated defect signals having the minimum peak separation of 4.8×10^{-3} cm (1.8×10^{-3} inch).

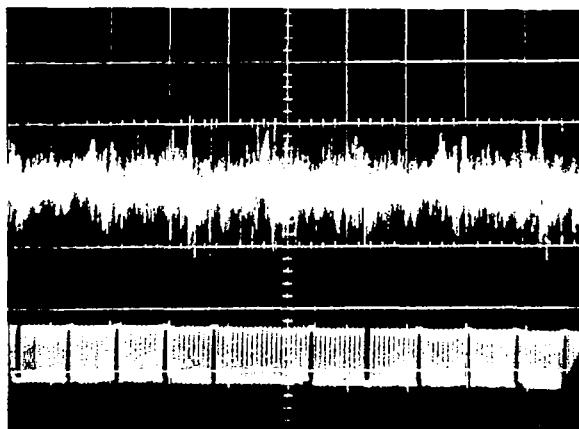
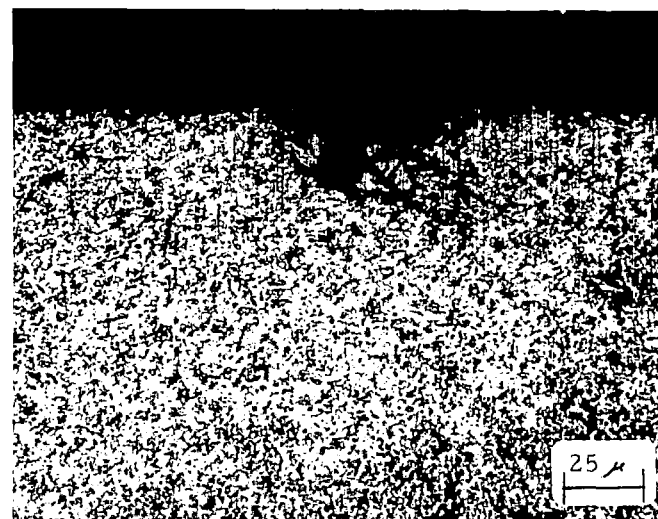
FIGURE 15. SPECIMEN #6 DEFECT SIGNAL AT 312° AND CORRESPONDING DEFECT. (Note cracking evident in unetched view (c)).

The next largest signal (absolute amplitude 53 mV) was associated with specimen No. 6; this defect (Figure 15) was particularly interesting, in that it touched the surface, and possibly would have resulted in a bearing failure in the event of longer running time. A slight darkening of the etched microstructure is evident near the inclusion. Note also that the inclusion was located axially at 347° , well outside the high stress zone.

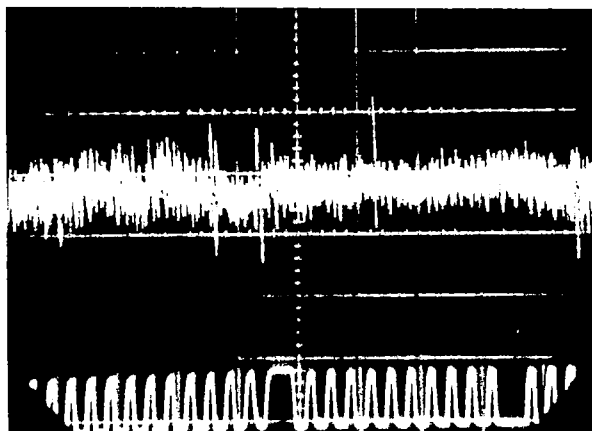
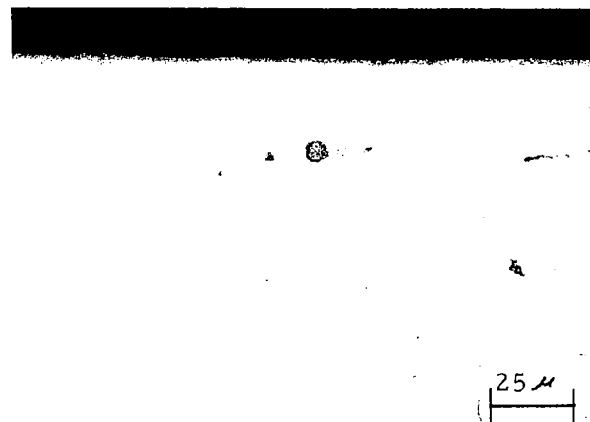
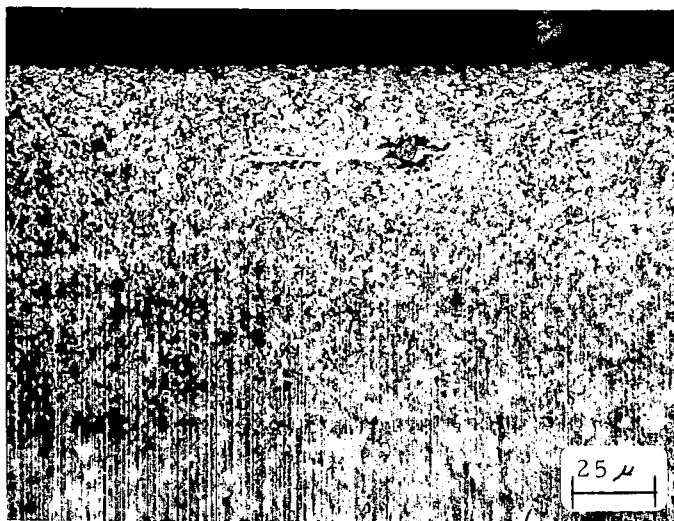
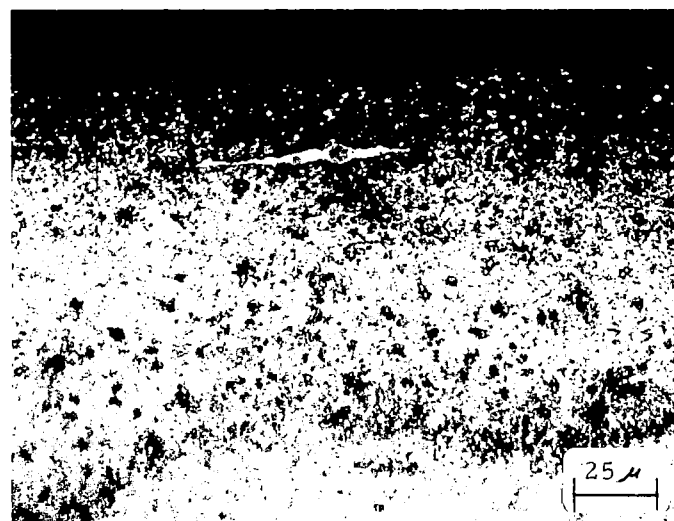
FIGURE 16. SPECIMEN #23 DEFECT SIGNAL AT 327° AND CORRESPONDING DEFECT.

Two other particularly interesting specimens were numbers 23 and 74. In each of these cases, the defects detected turned out to consist of planar sulfide sheets containing slender, rodlike silicate or aluminate "backbones," which may help explain the unique signal amplitude increases observed in these two cases. Figure 16 shows three sections through the defect of No. 23; a conceptual sketch of the particle may be seen in Figure 31. No cracks are visible at either inclusion site, indicating either that (1) soft inclusions are inefficient stress raisers, or (2) planar particles are more compatible with high rolling-contact stresses than are volume-equivalent spherical particles. The circumferential angles (2.5° and 7.7°) were such that shear stresses should have been quite high. The flaw in specimen No. 23 caused a 22 mV signal and in No. 74, a 25 mV signal; these are approximately the signal amplitudes associated with Nos. 24 and 130.

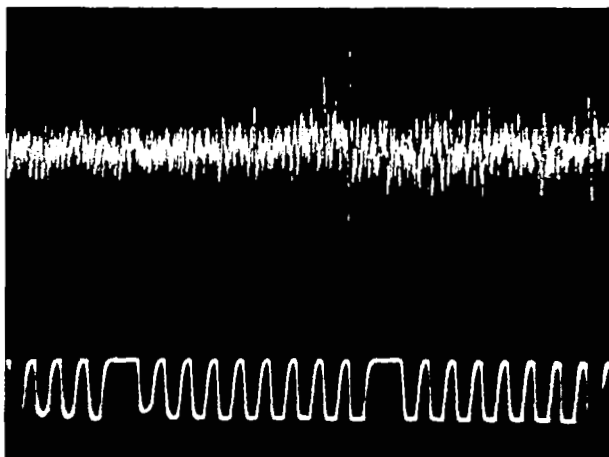
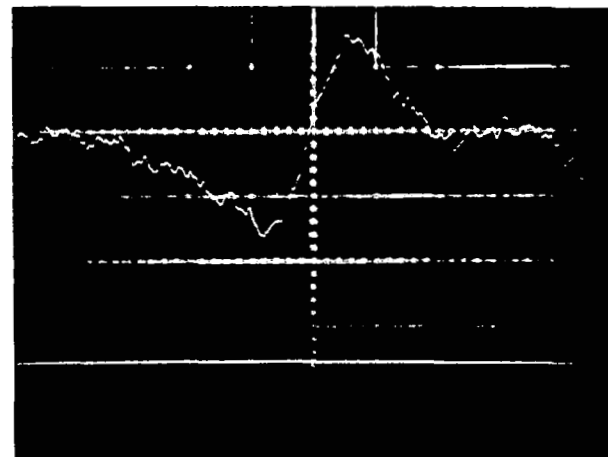
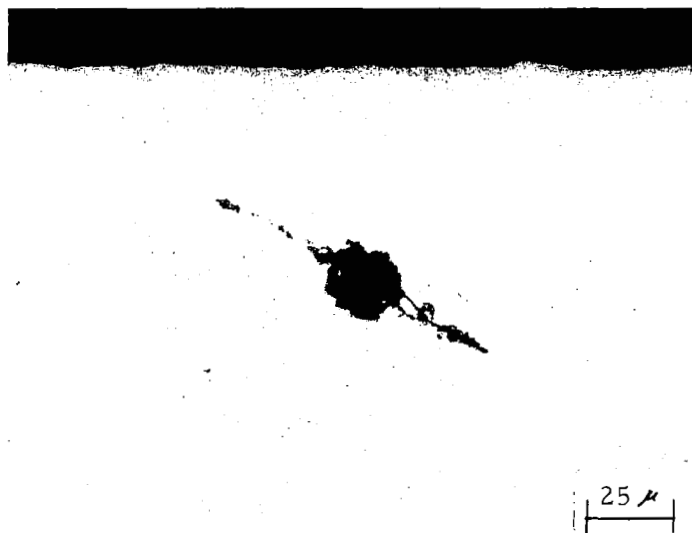
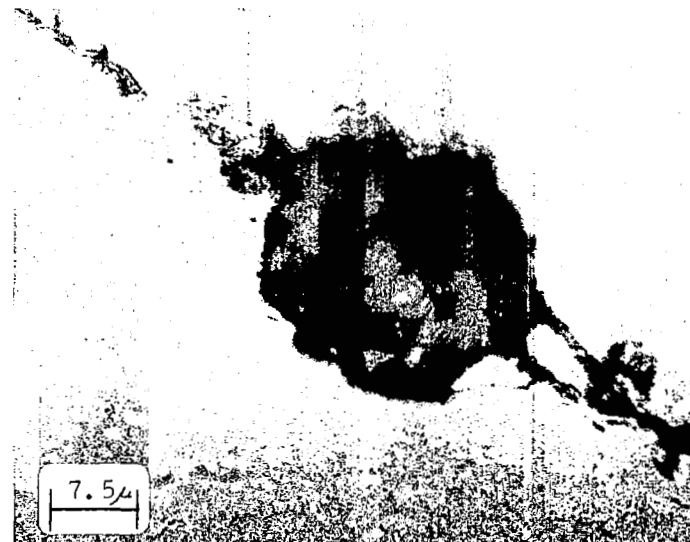
FIGURE 17. SPECIMEN #25 DEFECT SIGNAL AT 195° AND CORRESPONDING DEFECT

The defect of specimen No. 25 is rather interesting when compared with that which initiated the failure of No. 24. Both defects lie at the same equivalent axial position; No. 24 was 0.0069 cm (0.0027 inch) in diameter, while No. 25 measured 0.0028 cm (0.0011 inch); depths, on the basis of peak separation, were approximately equivalent; No. 25 lasted for 9,940 hours before the outer race finally failed, yet No. 24 failed at 1,902 hours at the defect site. Furthermore, No. 25 was essentially a duplex inclusion, i. e., an oxide a silicate particle sheathed within a sulfide. Since both radial and hoop matrix stresses increase with the volume of the inclusion, it is not so surprising that No. 25 should have a greater life expectancy. Further supporting this view is the association of the sulfide with No. 25; Brooksbank and Andrews³ have shown analytically that the presence of such soft

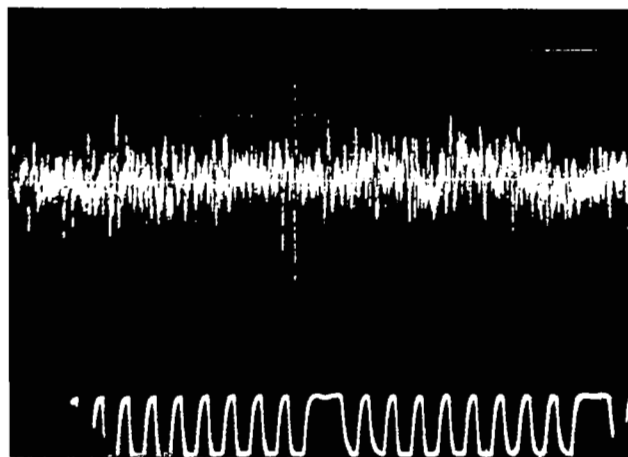
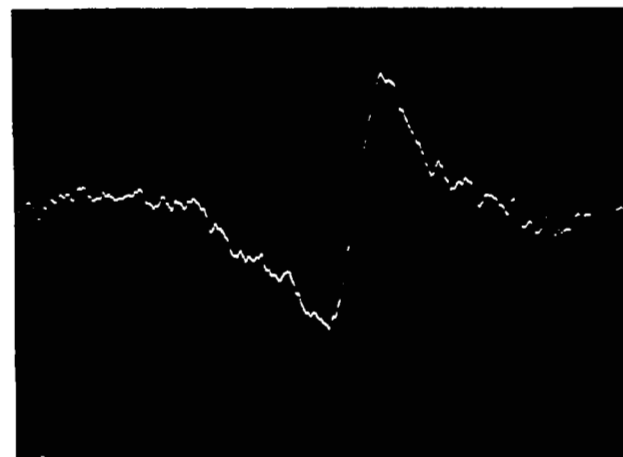
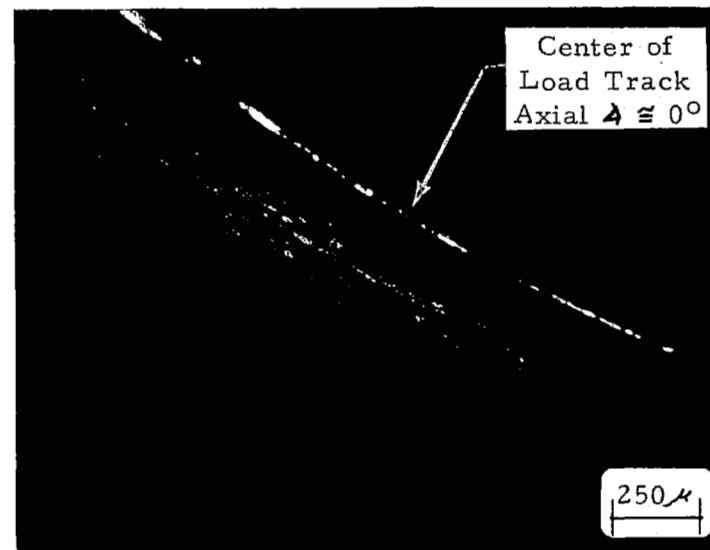
FIGURE 18. SPECIMEN #69 DEFECT SIGNAL AT 50° (a) AND (b), CORRESPONDING DEFECT (c), AND ETCHED SUBSURFACE PLASTIC ZONE (d).

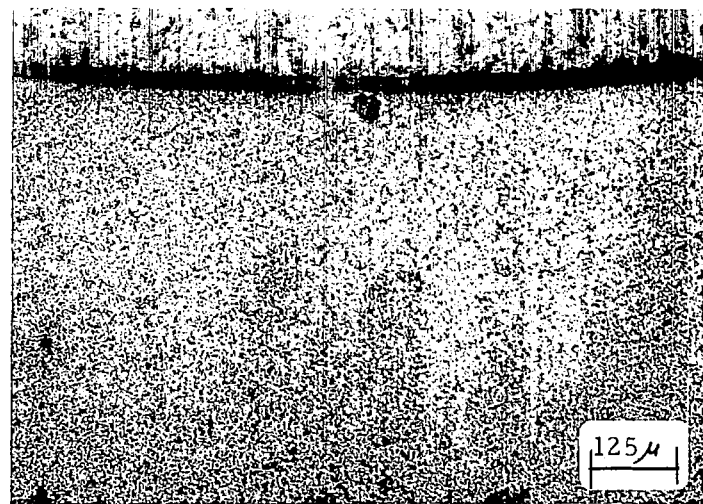
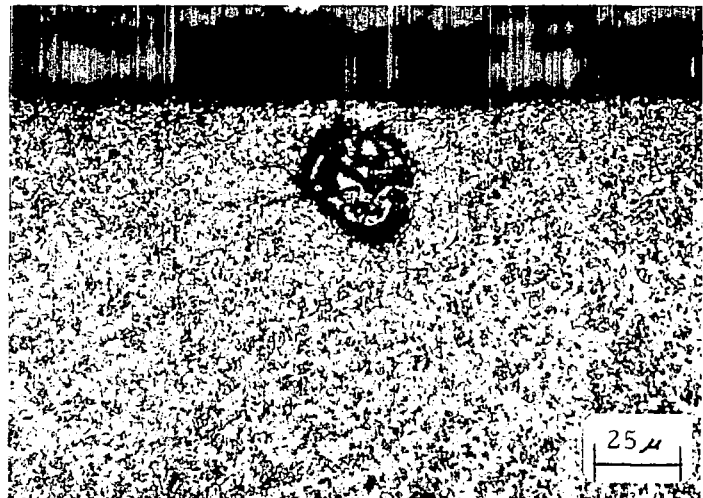
FIGURE 19. SAME DEFECT (SPECIMEN #69 AT 50°) SHOWN IN FIGURE 18, BUT 0.001 cm (0.0004 inch) DEEPER

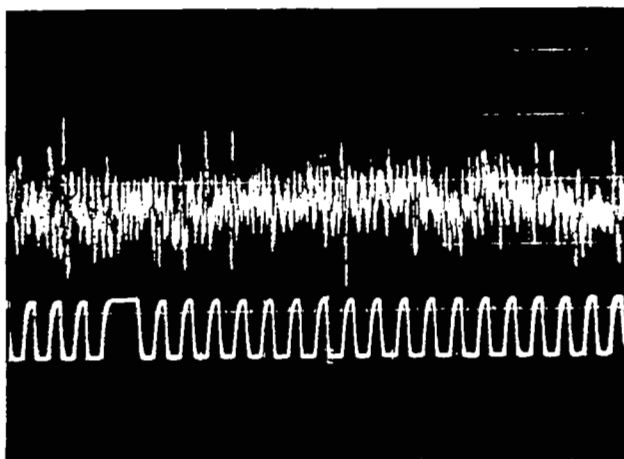
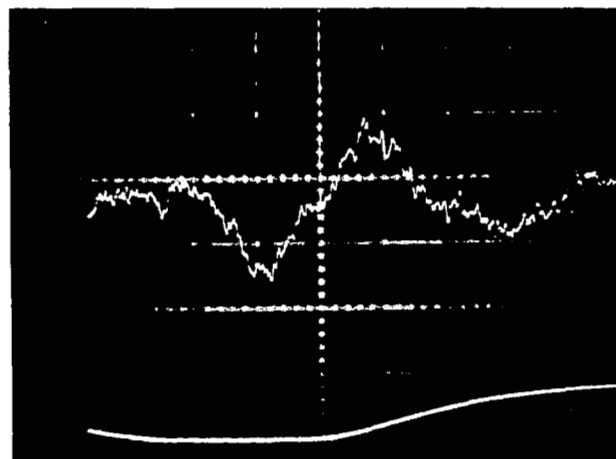
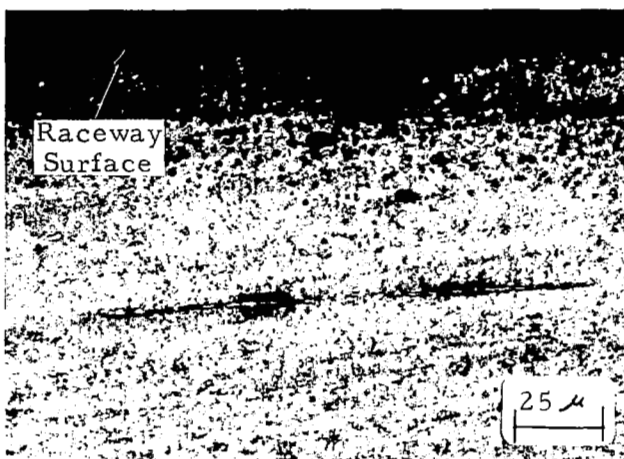
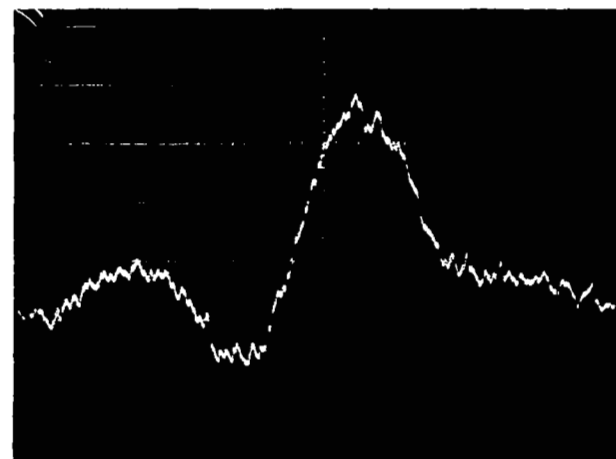
FIGURE 20. SPECIMEN #74 DEFECT SIGNAL AT 226° AND CORRESPONDING DEFECT; (b) AND (d) SHOW THE EXPANDED SIGNAL BEFORE AND AFTER ENDURANCE TESTING, RESPECTIVELY.

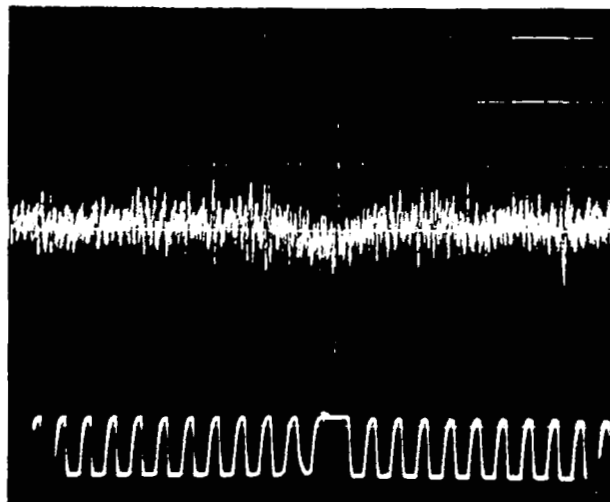
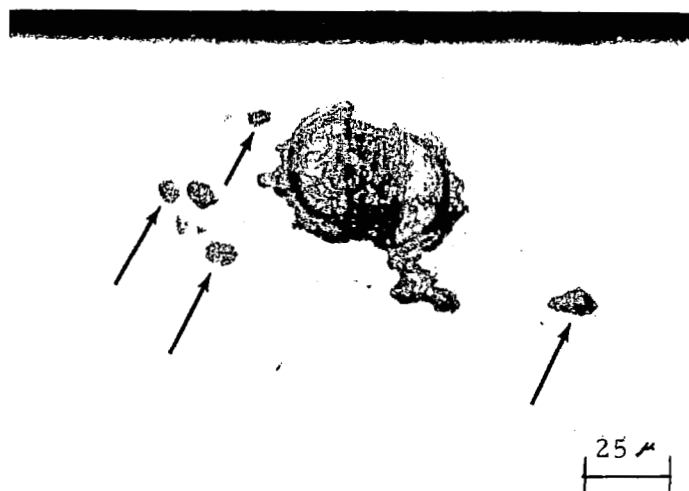
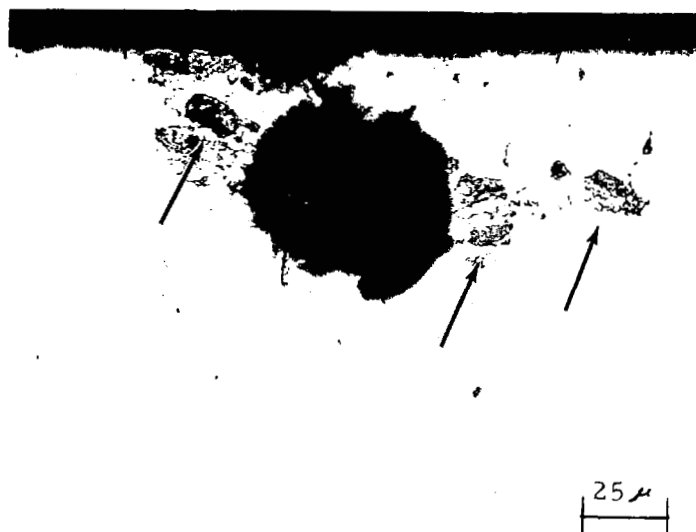
FIGURE 21. SPECIMEN #85 DEFECT SIGNAL AT 305° AND CORRESPONDING DEFECT. (Note sulfide particles (arrows) about the inclusions in (b) and (c), two sections separated by 12.5μ).

Because of the high signal amplitude (49 mV) and signal-to-background ratio associated with No. 85, one might have suspected damage at this site. However, three factors mitigate against this supposition. First, the measured depth of the inclusion was only 0.003 cm (0.0012 inch), although its size was equal to the defect which caused No. 130 to fail. Close inspection using polarized light, however, indicates that this inclusion was partially surrounded by sulfide, and that associated with it were several smaller sulfide particles (arrows in Figure 21). This second factor may help explain the lack of microcrack

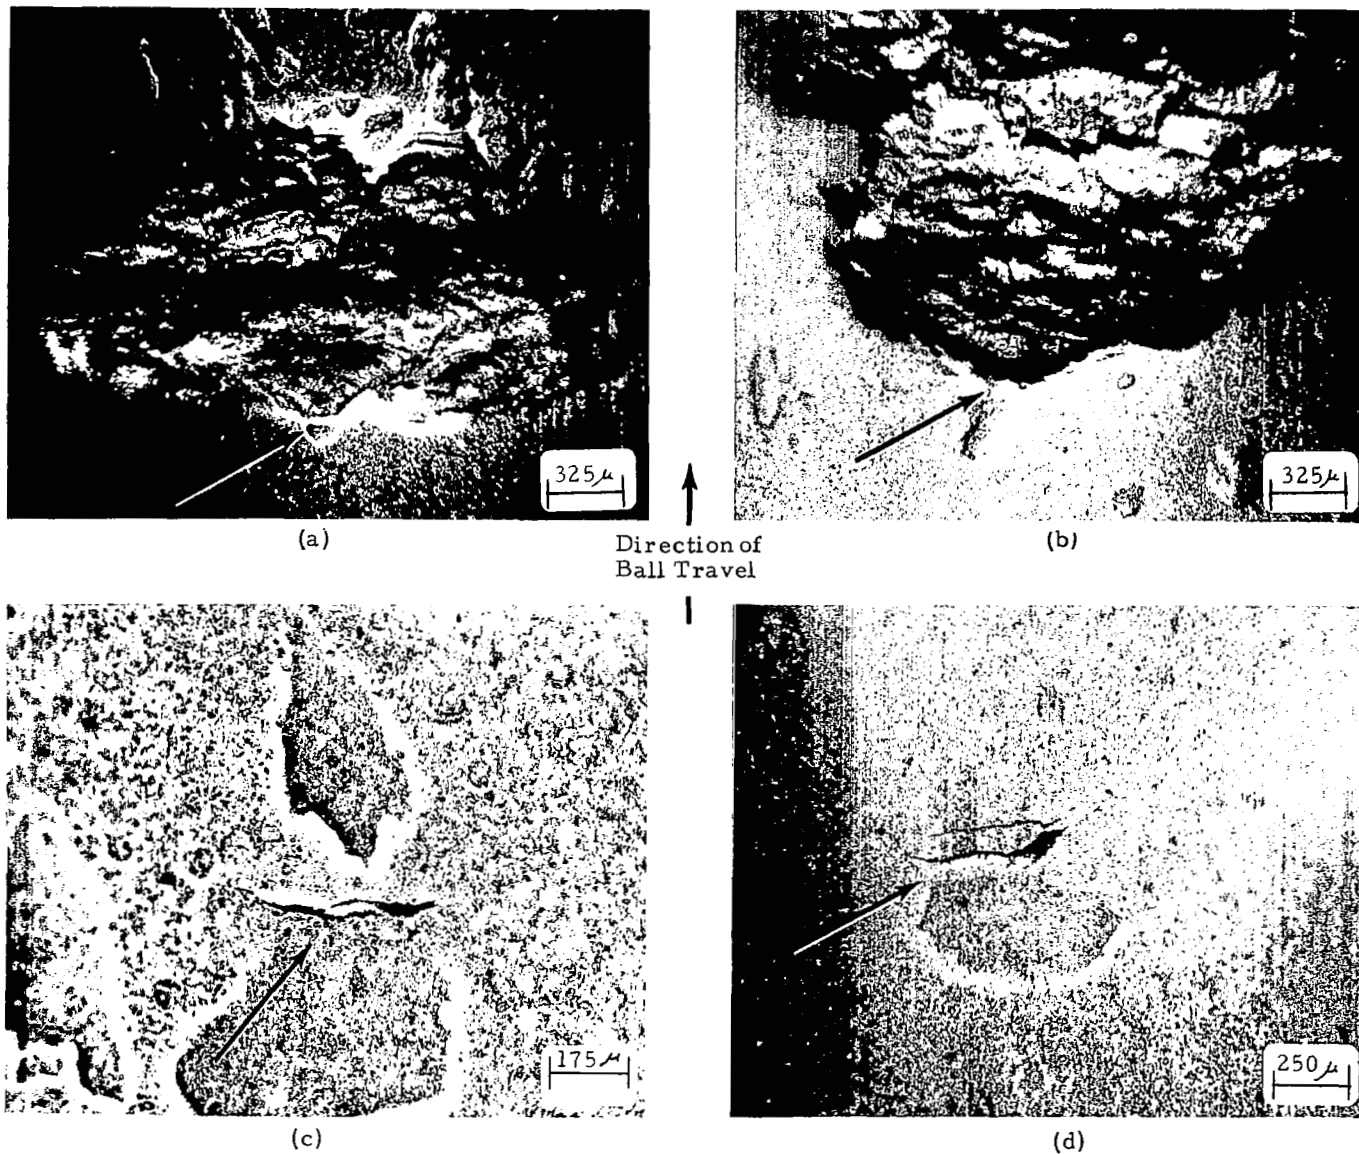
In all (13) cases of spalling which could not be traced to subsurface inclusion nucleation, i. e. , excluding specimens 24 and 130, it was observed that initiation of the spalls was caused by surface damage (one or two bearings were damaged so severely that one could not be positive that every spall was caused by an indent rather than a subsurface flaw). This damage always consisted of indentations lying just at the leading edge of each spall, examples of which are shown in Figure 23 (a-b). The direction of ball travel is shown by an arrow. While it is not known precisely at what time these indents were introduced, they definitely were not present following magnetic field perturbation inspection prior to the bearing fatigue tests. It is important to note that a spall will not necessarily nucleate at every indentation formed on a raceway surface.

Where spalls did initiate at indentations, the failure process proceeded as shown in Figure 23 (c-d). Here, microcracks have formed at the trailing edge of local indents. Beneath the surface, the crack profile appears as shown in Figure 24; note that the crack extends only a short distance beneath the surface before leveling off and growing parallel to the raceway surface. Subsequent spalling-out of material produces the macro-failures, or spalls, of Figure 23 (a-b).

FIGURE 23. SPALLS (a-b) AND PRE-SPALL CRACKING (c-d) AT SURFACE INDENTS. (Arrows indicate spall formation at trailing edge of indents).

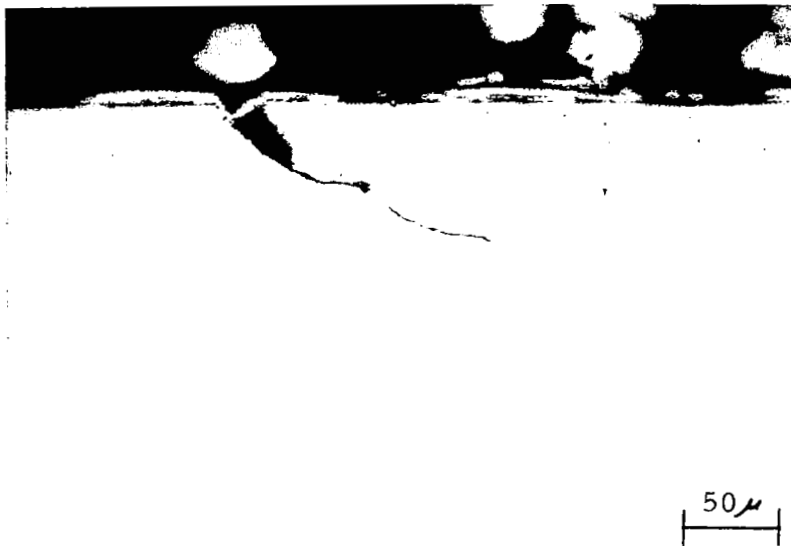
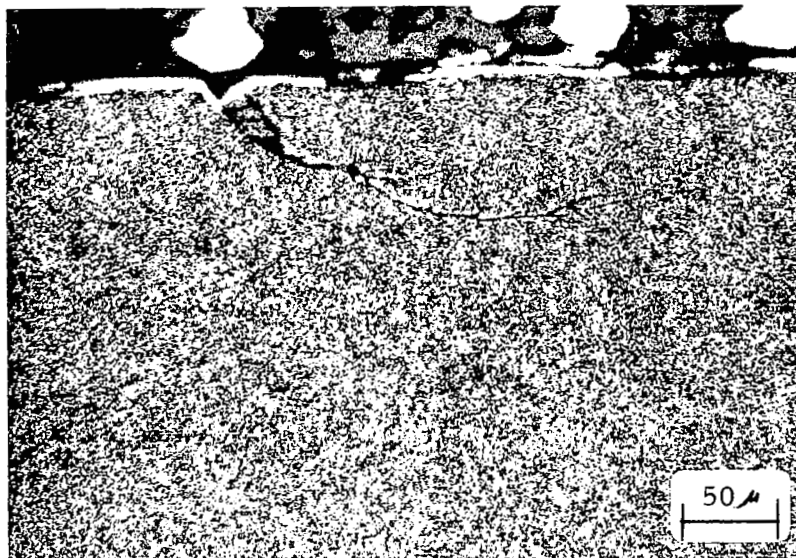
FIGURE 24. SECTION THROUGH CRACK AT TRAILING EDGE OF INDENT, (a) UNETCHED, (b) ETCHED. (Situation similar to that of Figure 23 (c-d).)

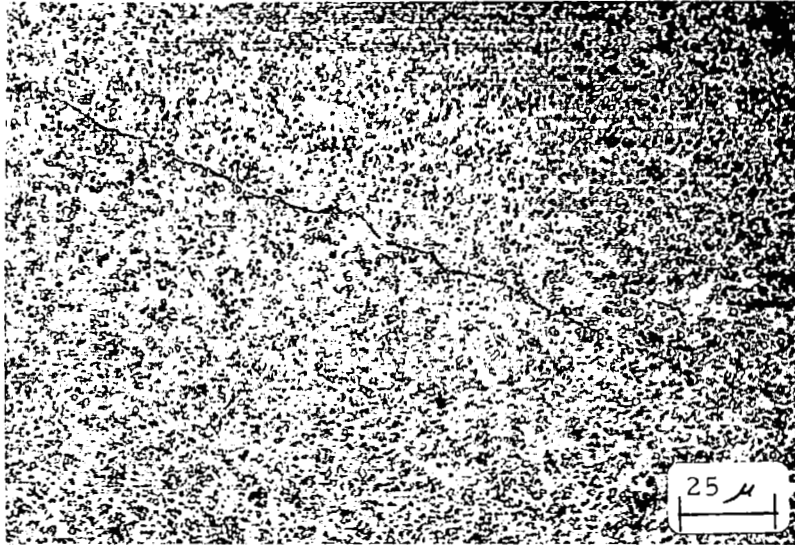
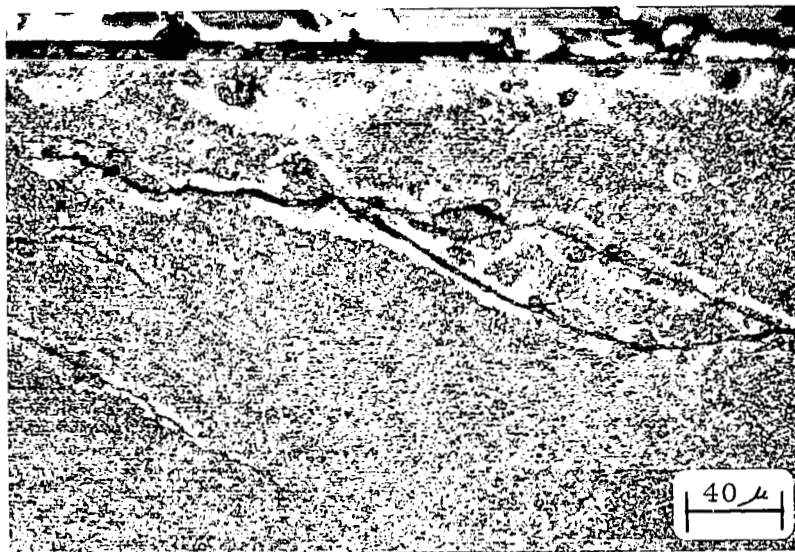
In sectioning through spalled regions, two general types of crack configurations were encountered. The first case is shown in Figure 25(a), in which the crack propagates in the absence of any apparent plastically deformed (white etching) zone along the crack interface. Compare this behavior with that shown in Figure 25(b). The reason for this difference is not known, although it is interesting that both types of crack usually lie at an angle of approximately 28° with respect to the bearing surface (See Figure 25(a)). In addition, it appears from photos such as that of Figure 25(a) that the dispersed chromium carbides (white spots) have little or no control over crack growth, since no special carbide configurations are evident along the crack interface.

FIGURE 25. SUBSURFACE CRACK CONFIGURATION

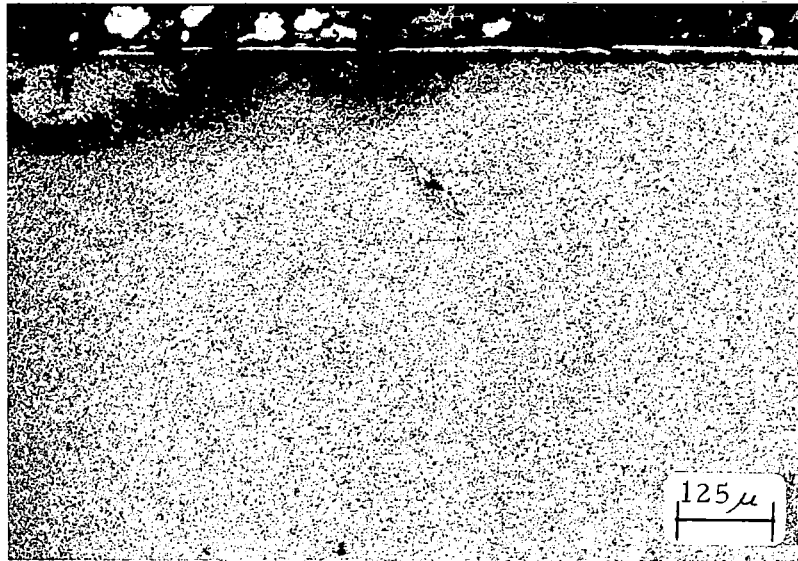
During sectioning, only a few "butterflies" were encountered; an example of one is shown in Figure 26. It is interesting to note that (1) the "butterfly" is oriented at an angle of approximately 45° with respect to the surface, and (2) the depth of the inclusion is 0.018 cm (0.007 inch), well within the most highly stressed zone. In Figure 26(b), note that cracking within the "butterfly" has begun. This defect was too small ~ 0.005 cm (0.002 inch dia.) and deep to permit magnetic perturbation detection.

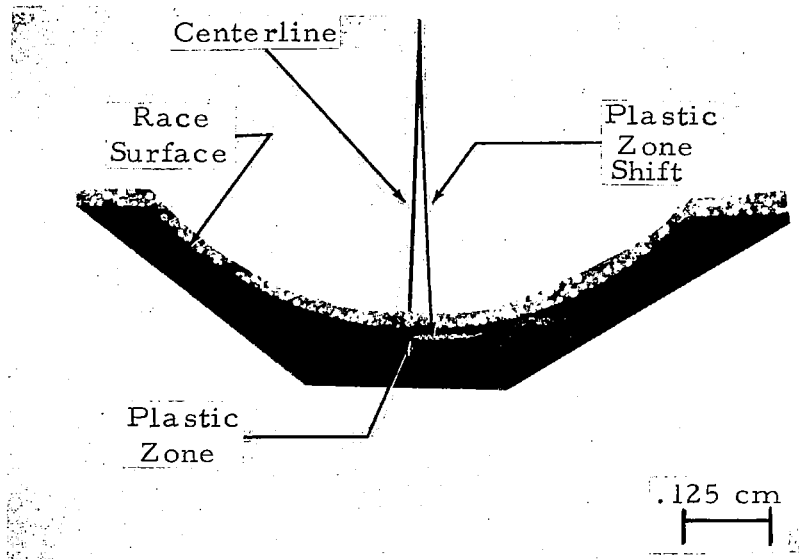
FIGURE 27. SECTION THROUGH BEARING #74 SHOWING PLASTIC ZONE SHIFT OF 2° FROM CENTERLINE OF BEARING

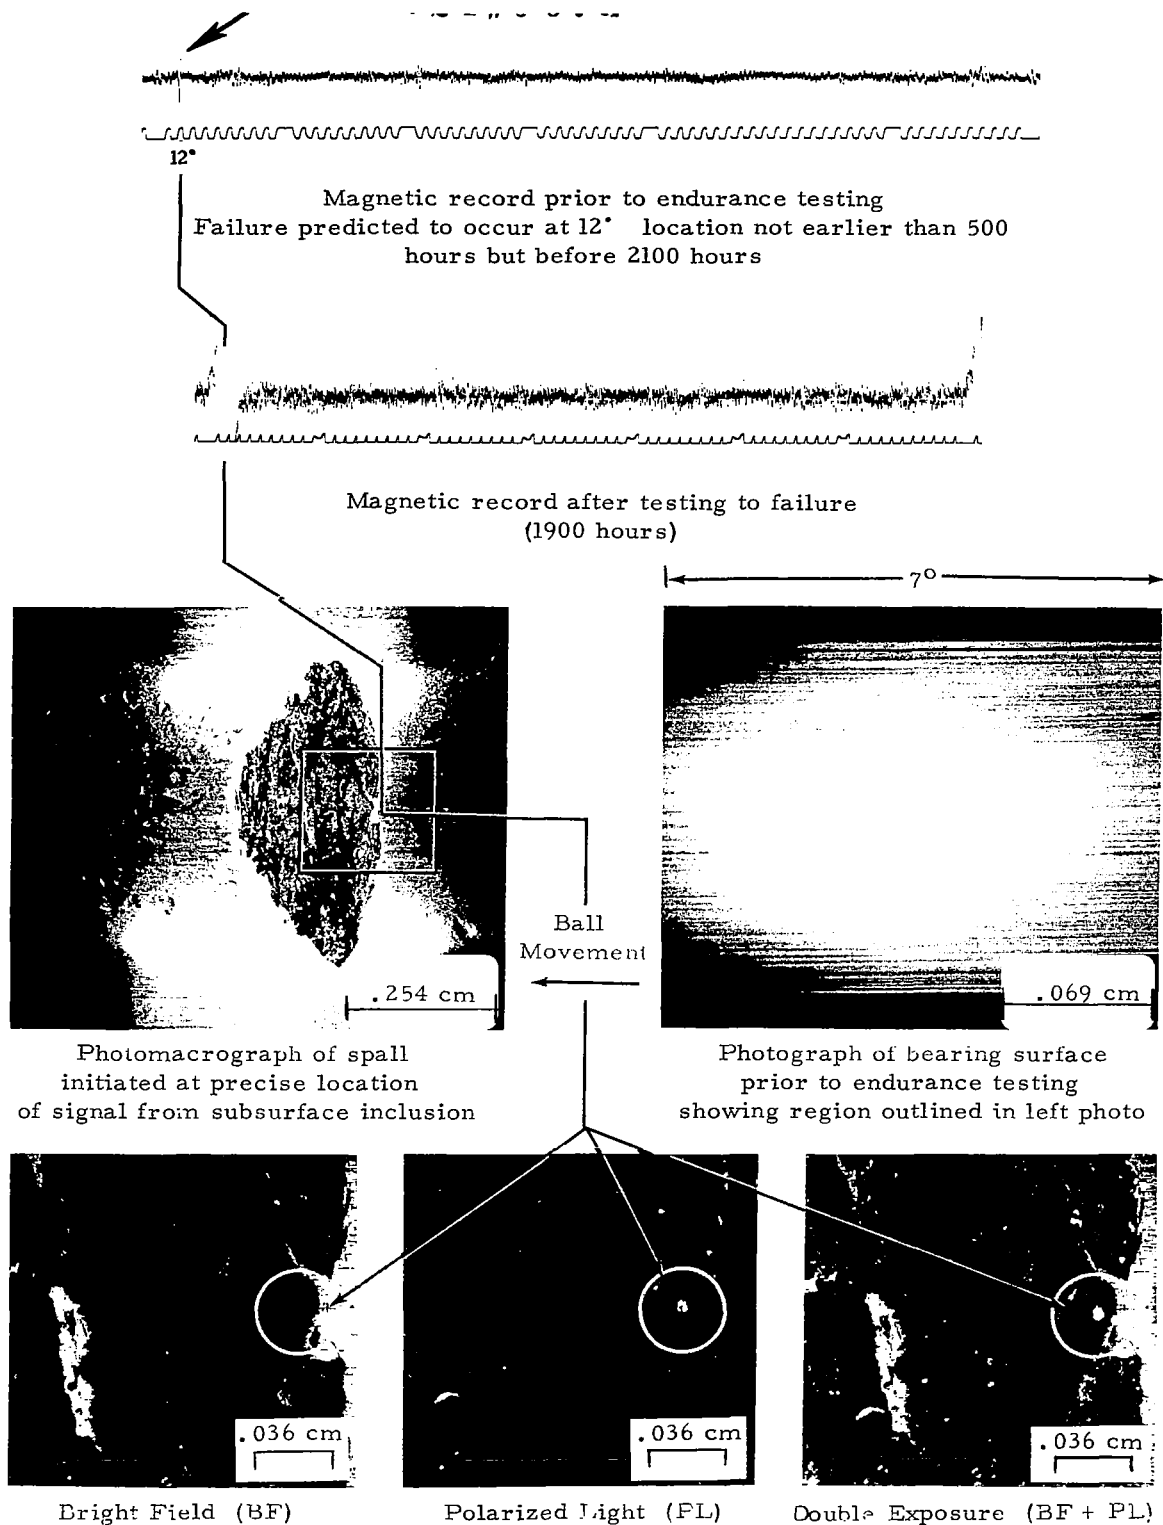
Since specimens 24 and 130 provided the most dramatic evidence of the potential inherent in magnetic perturbation inspection of bearings, these two cases are shown pictorially in Figures 29 and 30. Note in particular (Figure 29) the 0.0069 cm (0.0027 inch) diameter nucleating inclusion, preserved within the spall region, which caused the failure of specimen No. 24. This inclusion could be viewed effectively only by means of polarized light. Although the inclusion responsible for nucleating the failure shown in Figure 30 apparently was lost during some phase of spalling, there obviously exists excellent correlation between the signal site at 308° and the leading edge of the spall. Close optical inspection of the leading edges of both spalls (24 and 130) showed no evidence of indentation.

FIGURE 29. LIFE PREDICTION - FAILURE INITIATED AT SUBSURFACE INCLUSION

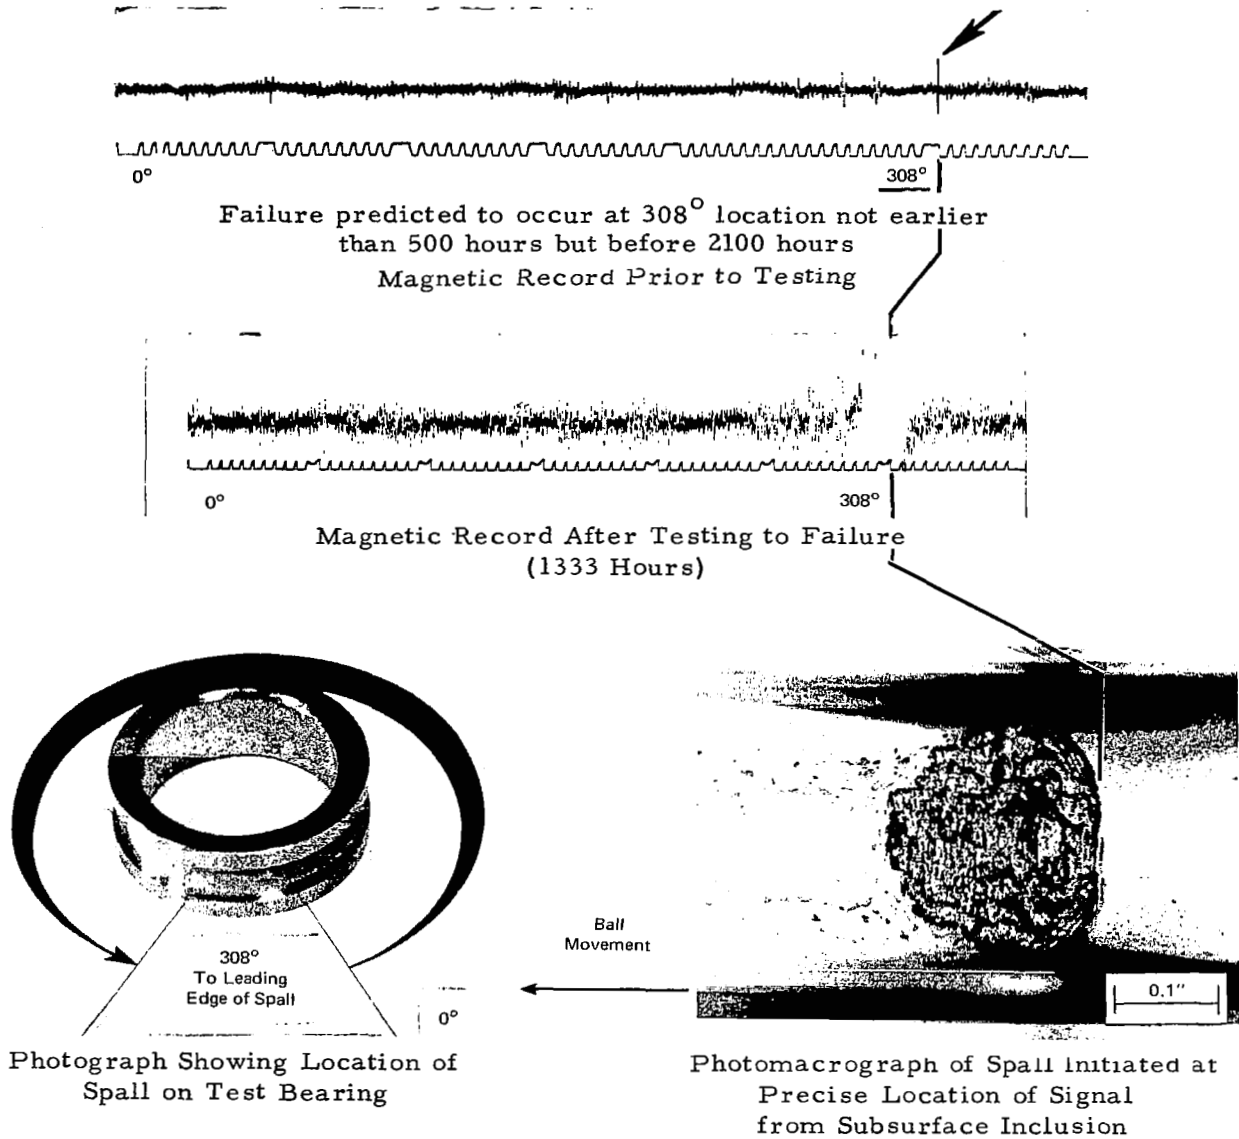
FIGURE 30. SPALL AT PREDICTED SITE IN BEARING #130

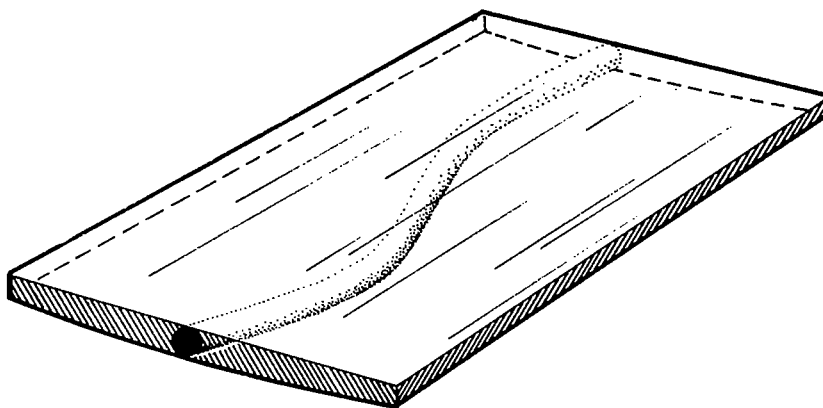
FIGURE 31. PLANAR DUPLEX INCLUSION, SHOWING SILICATE OR ALUMINATE "BACKBONE" WITH SULFIDE SHEET.
